Delivery Report

## Plastic litter detection and Water Quality Monitoring in Lake Como, Italy

Date: April 30, 2026 | Client: ESA/Westbrook Racing

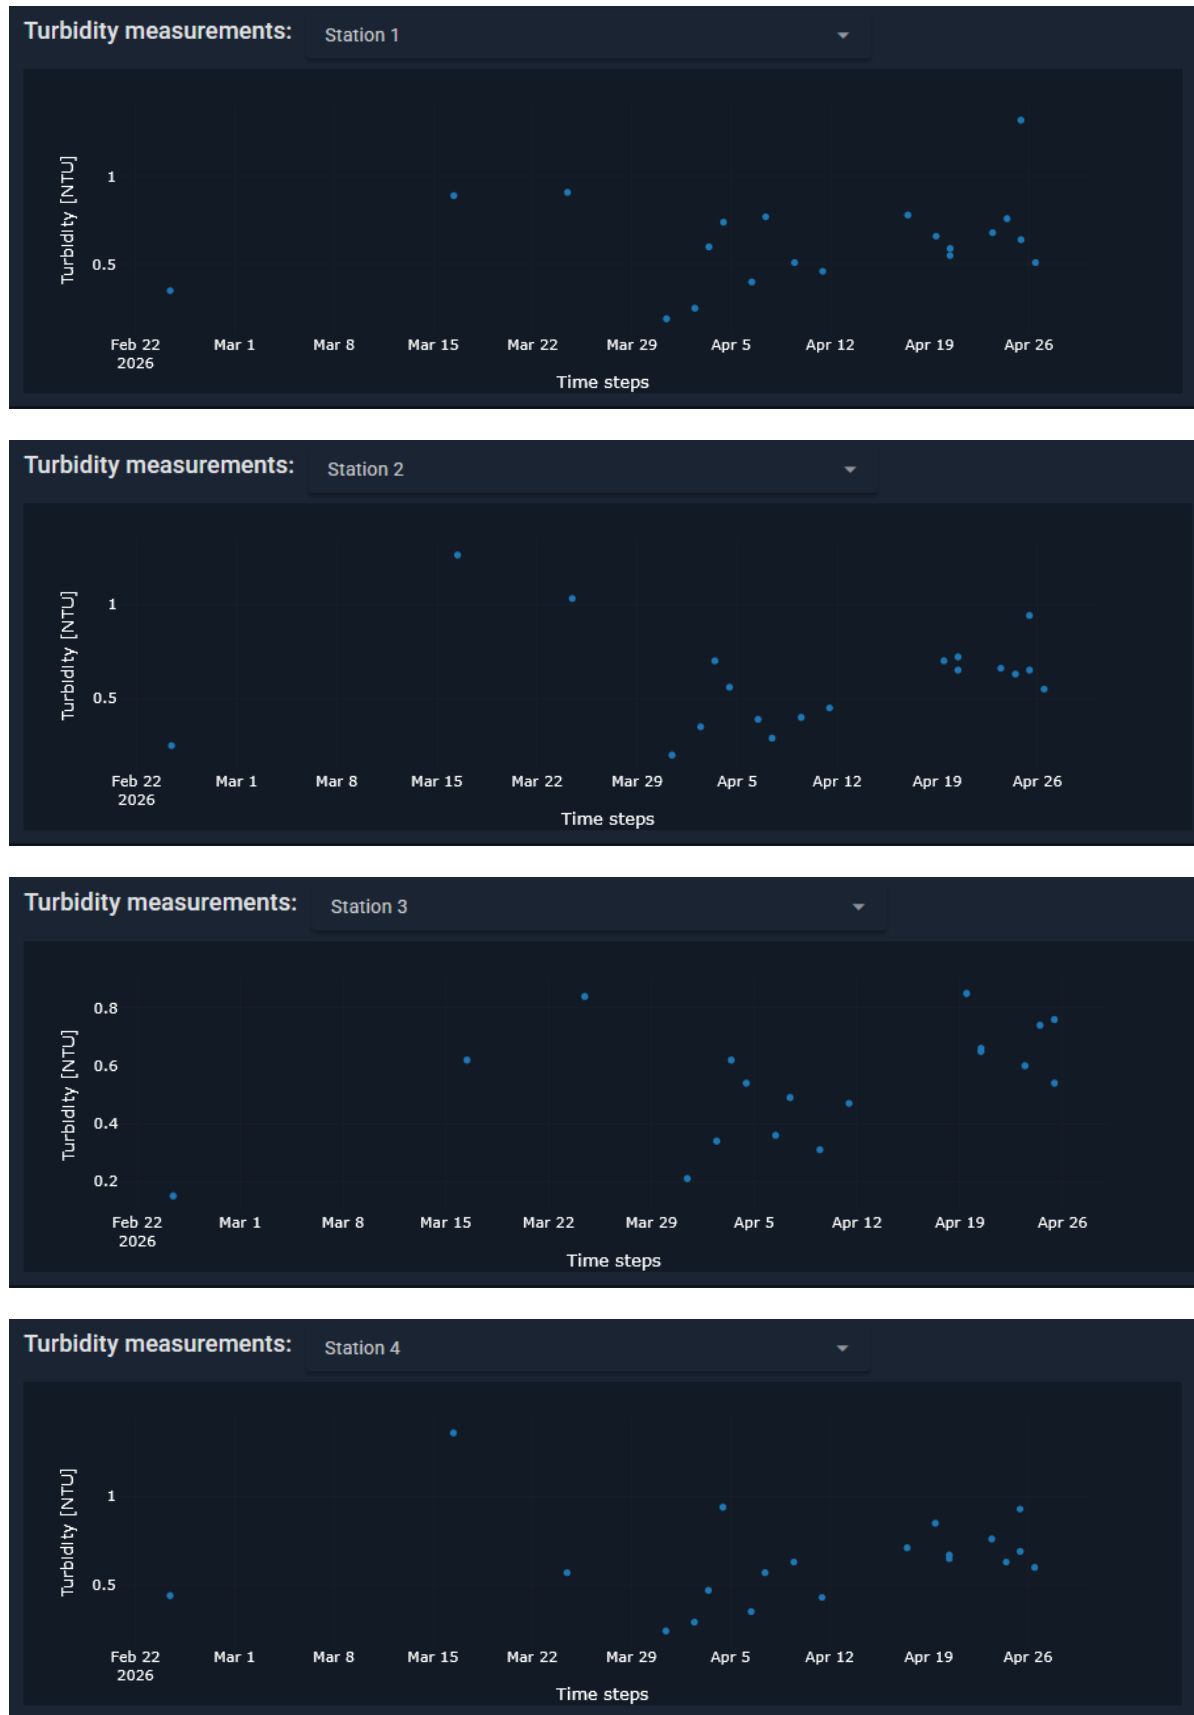
Figure 12: Turbidity measurements at 4 points in the actual race location. The order of panels follows following order from top to bottom: Station 1, Station 2, Station 3, Station 4

To assess the potential impact of the race on water turbidity, four monitoring stations were established at which turbidity values were evaluated (Figure 11). The results are presented in Figure 12. Across all stations, average turbidity values are around 0.5 NTU, with maximum values reaching approximately 1 NTU. **No clear difference can be observed between turbidity levels before and after the race event.** This finding is consistent with the time series analysis and weekly maps of turbidity. Consequently, the race event at Lake Como did not have had a measurable impact on turbidity, Secchi depth, or chlorophyll concentrations.
