**Delivery Report**

## **Plastic litter detection and Water Quality Monitoring in Luanda, Angola**

**Date:** September 18, 2026

**Client:** ESA/ Westbrook Racing by Visit Angola

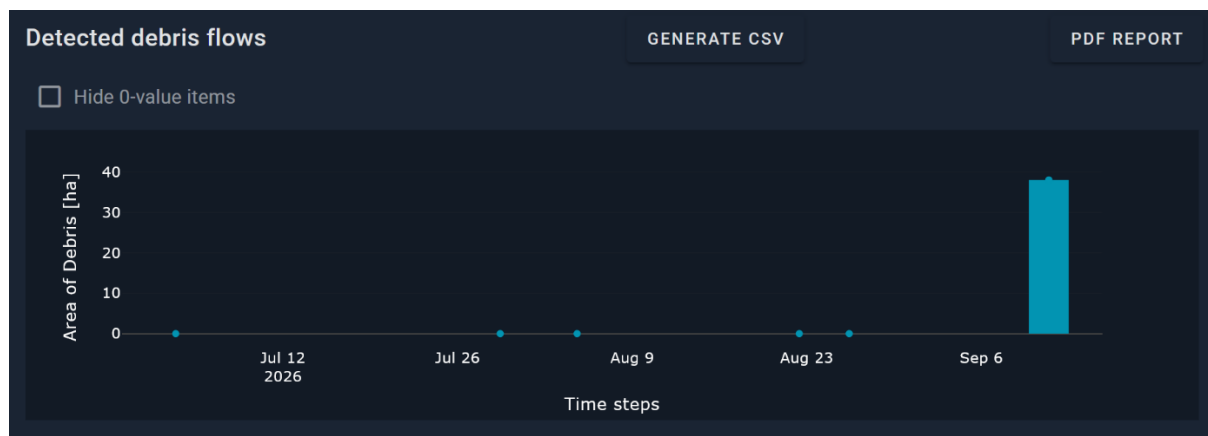
Figure 4: Plastic litter statistic across the monitoring time series (featuring the formation detected on September 11<sup>th</sup>)

Plastic litter detection was conducted within the Race Location (Figure 1 – number 1) and is based on Planet data. The results are displayed in the Eyes-on-Plastic platform (Figure 3). Across all analysed time steps, no **plastic litter detections** were identified in the Luanda Bay - indicated by the blue circles that are at the 0-level on the x-axis in Figure 4.

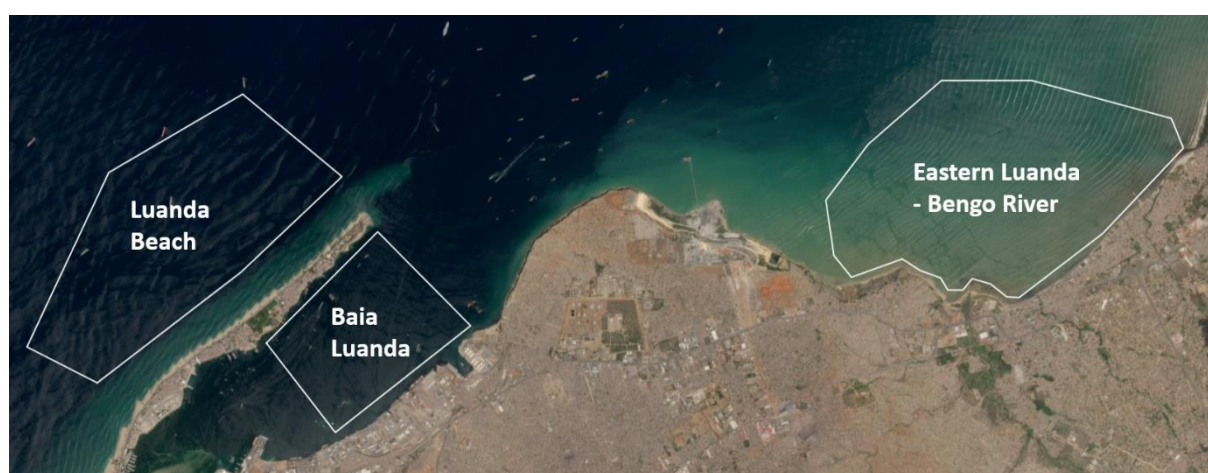
Figure 5: Virtual stations created over the Extended Area for water quality monitoring.

To analyse water quality information three virtual stations were created across the Extended Area in the eoapp AQUA to provide averaged polygon statistics across these observation spots. These stations, indicated by the white polygons in Figure 5, constitute arbitrary shapes and can be created by any user individually in the eoapp AQUA.

The following assessment includes box plot statistics for the three observed regions Baia de Luanda, Luanda Beach and Eastern Luanda – Rio Bengo (Figure 5). The analysis includes percentile and median analysis, accomplished for the four parameters Turbidity, Chlorophyll, Secchi Depth and Algae Risk Indicator. The analysed time frame covers November 2025 until September 2026.

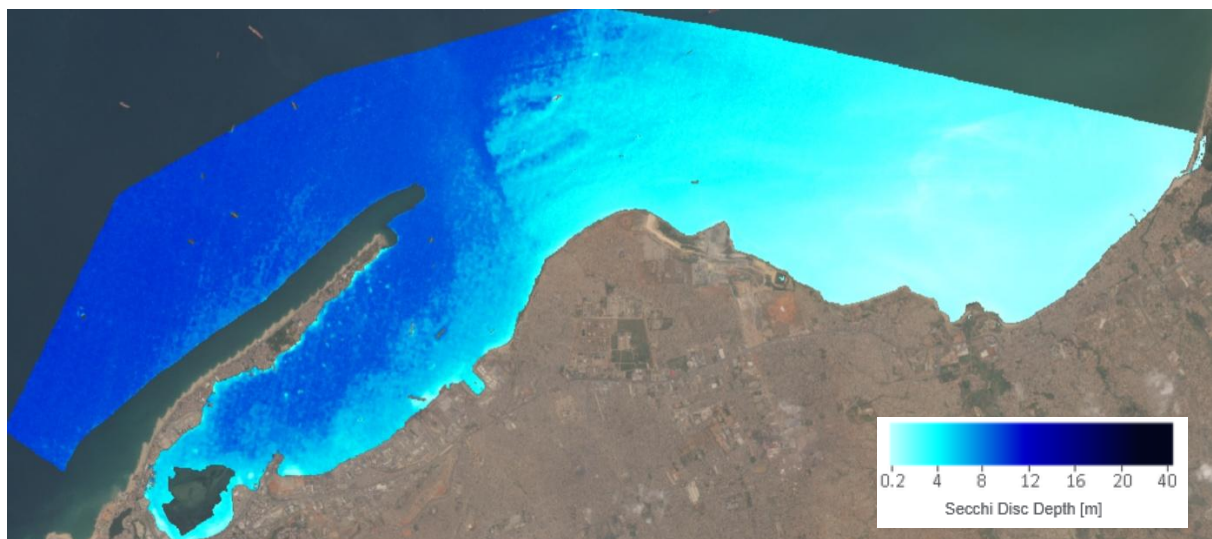
Figure 13: Secchi Depth map showing the visibility on 3<sup>rd</sup> July 2026 – the scene shows good visibility at Luanda Beach, medium visibility in the Luanda Bay and low visibility in the Eastern part of Luanda

Luanda Beach shows the best visibility, with an average Secchi depth of 9 m and little fluctuation. Luanda Bay has lower visibility at approximately 6 metres, while the East shows the lowest visibility with only 2 metres. This spatial pattern and its fluctuation are similar to those seen in the other parameters.

It should be noted that visibility shows a sharp divide around Ponta Lagostas: areas East of this line have on average significantly lower visibility than areas to the West. In the extreme East, visibility drops locally to 1 metre or lower in some scenes.
